## Highways Drainage Monmouthshire, Wales UK.

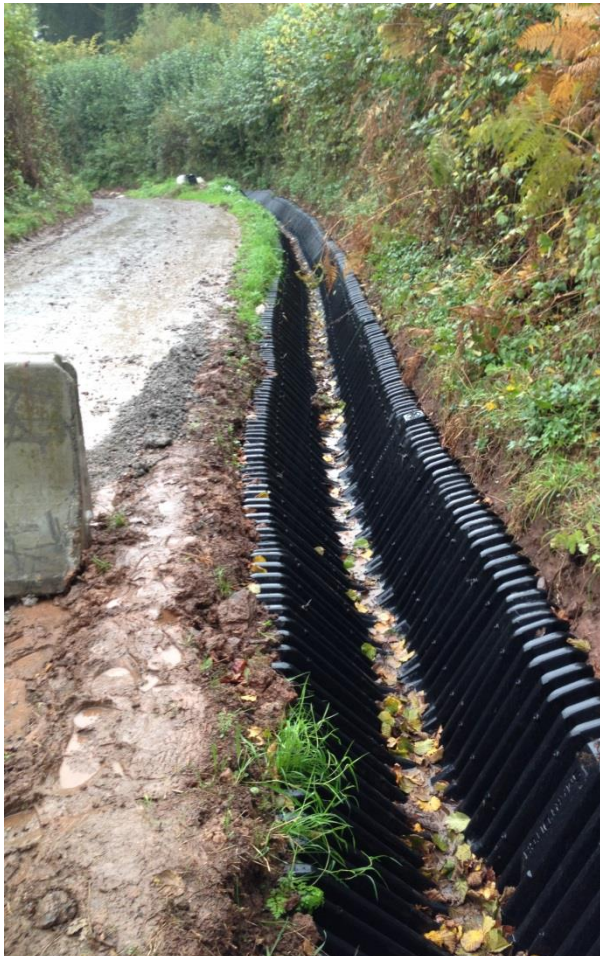
SmartDitch Installed along the side of the road

A 12" deep Trapezoidal SmartDitch was used for the ease of installation and savings in time and materials. The engineers wanted a durable and leak proof material they could obtain and use quickly to prevent further saturation and which could cope with the gradient and curvature of the road.

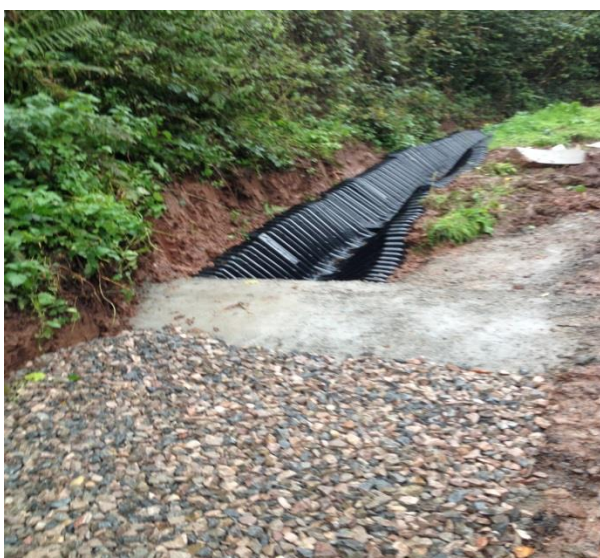
The SmartDitch flows into a culvert at a passing place

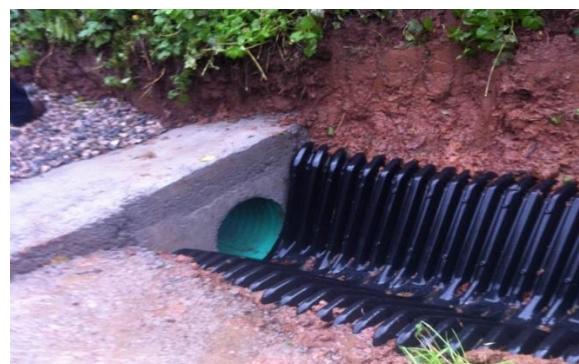
SmartDitch is sealed against the concrete face
